Enbridge Incorporated
Hazardous Liquid Pipeline Rupture and Release
Marshall, Michigan
July 25, 2010

NTSB/PAR-12/01
PB2012-916501

Pipeline Accident Report

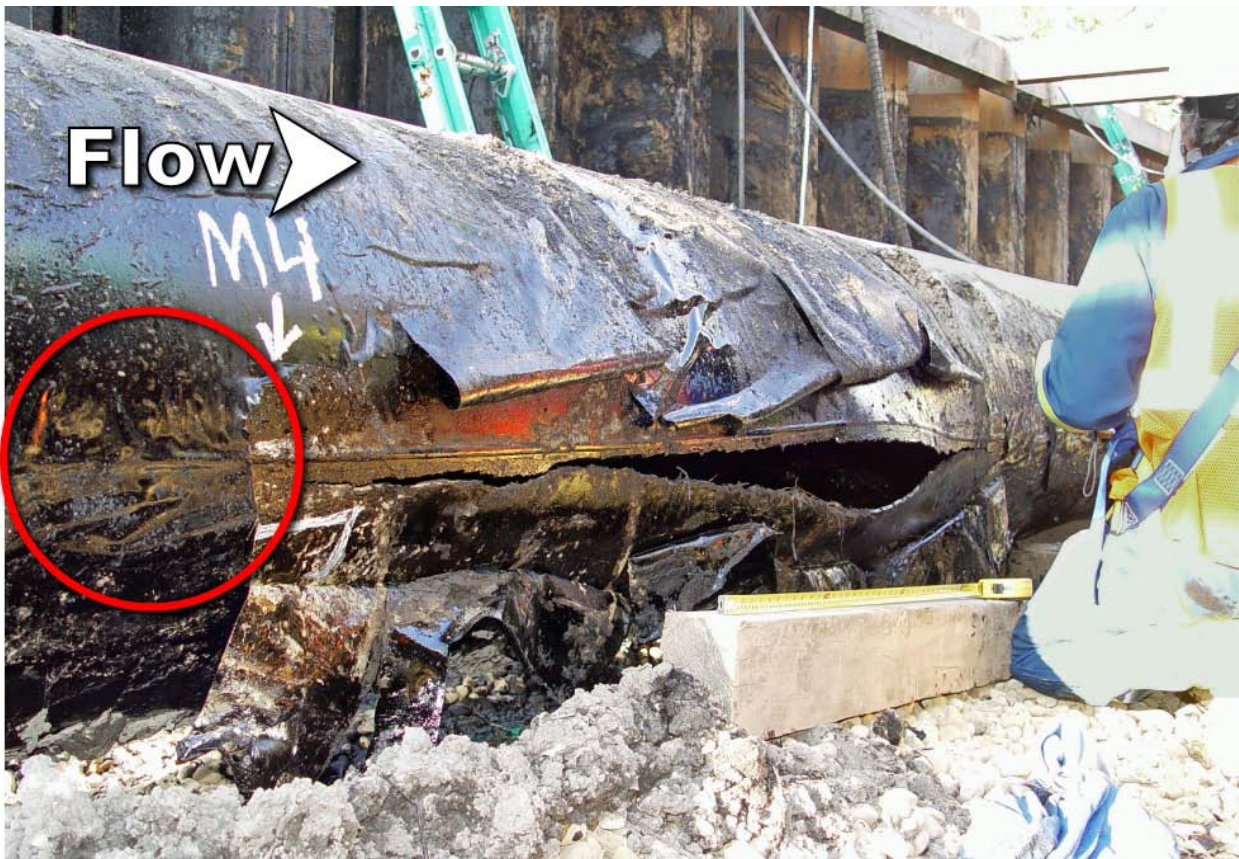
The fracture in the ruptured segment measured 6 feet 8.25 inches long and up to 5.32 inches wide. (See figure 2.) External corrosion was present along the longitudinal weld seam and in areas where the adhesive bond between the pipe and its protective polyethylene tape coating had deteriorated (disbonded). The coating was wrinkled and had separated from the pipe surface as shown in the red circle in figure 2.

Figure 2. The ruptured segment of Line 6B in the trench following the July 25, 2010, rupture. The fracture face measured about 6 feet 8.25 inches long and was 5.32 inches wide at the widest opening. The fracture ran just below the seam weld that was oriented just below the 3 o'clock position. A red circle shows a location where the coating was wrinkled and had separated from the pipe surface.

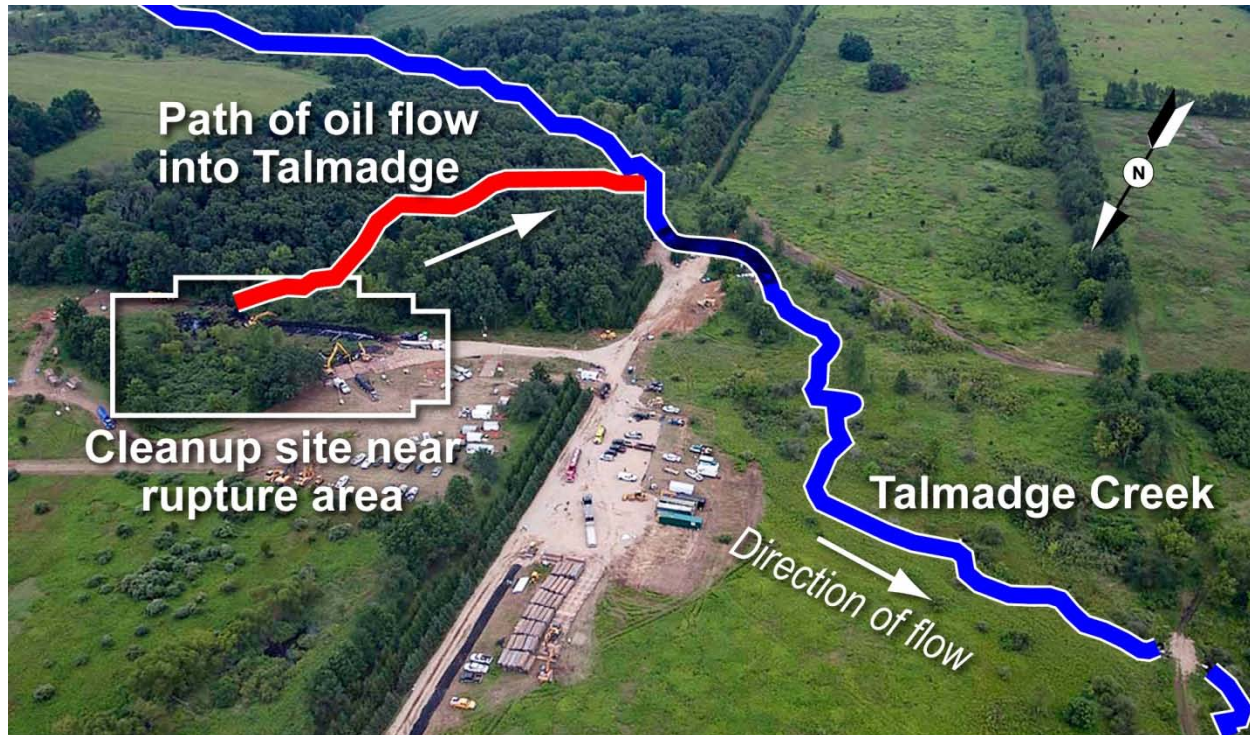
The crude oil release soaked the rupture site and the surrounding wetlands, eventually spreading to the Talmadge Creek and the Kalamazoo River. Enbridge's early response efforts were focused downstream of the rupture. Recent heavy rainfall had increased the flow of the Talmadge Creek and the Kalamazoo River, which spread the oil faster, hindering the response efforts. (See figure 3.)

Figure 3. Aerial view of the accident location showing the rupture site to the left and the Talmadge Creek flowing west toward the Kalamazoo River.

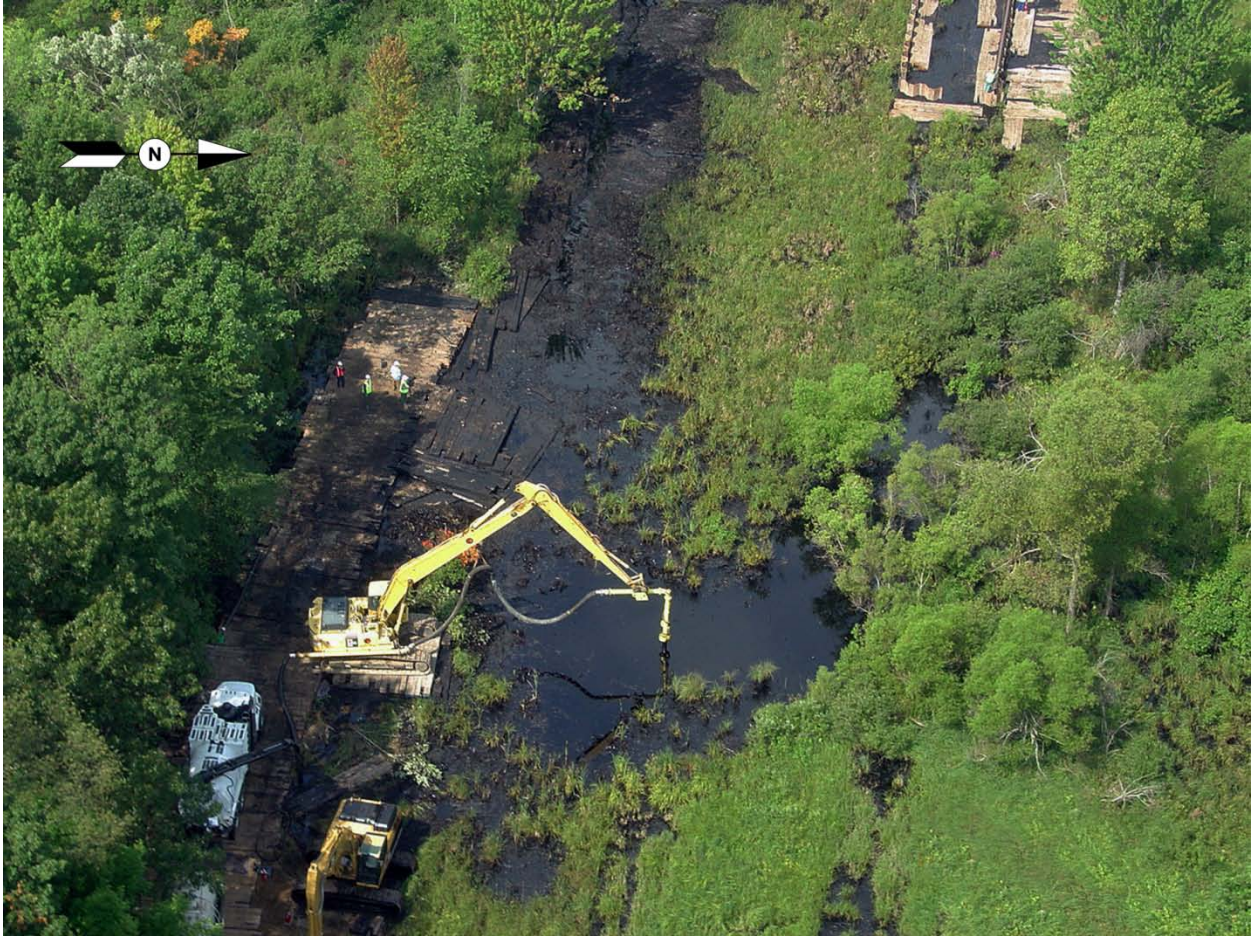
The wetland conditions in addition to the crude oil release made it difficult for vacuum trucks and excavators to get near the rupture location. Large wooden matting had to be placed around the rupture location to bring heavy equipment close to the release. (See figure 4.) The conditions at the accident site also delayed efforts to extract the pipe and to contain the oil near the rupture source.

Figure 4. Cleanup efforts in an oil-soaked wetland near the rupture site. Saturated soil complicated the cleanup and excavation efforts. An excavator with a vacuum attachment is shown situated on wooden matting near the rupture site.

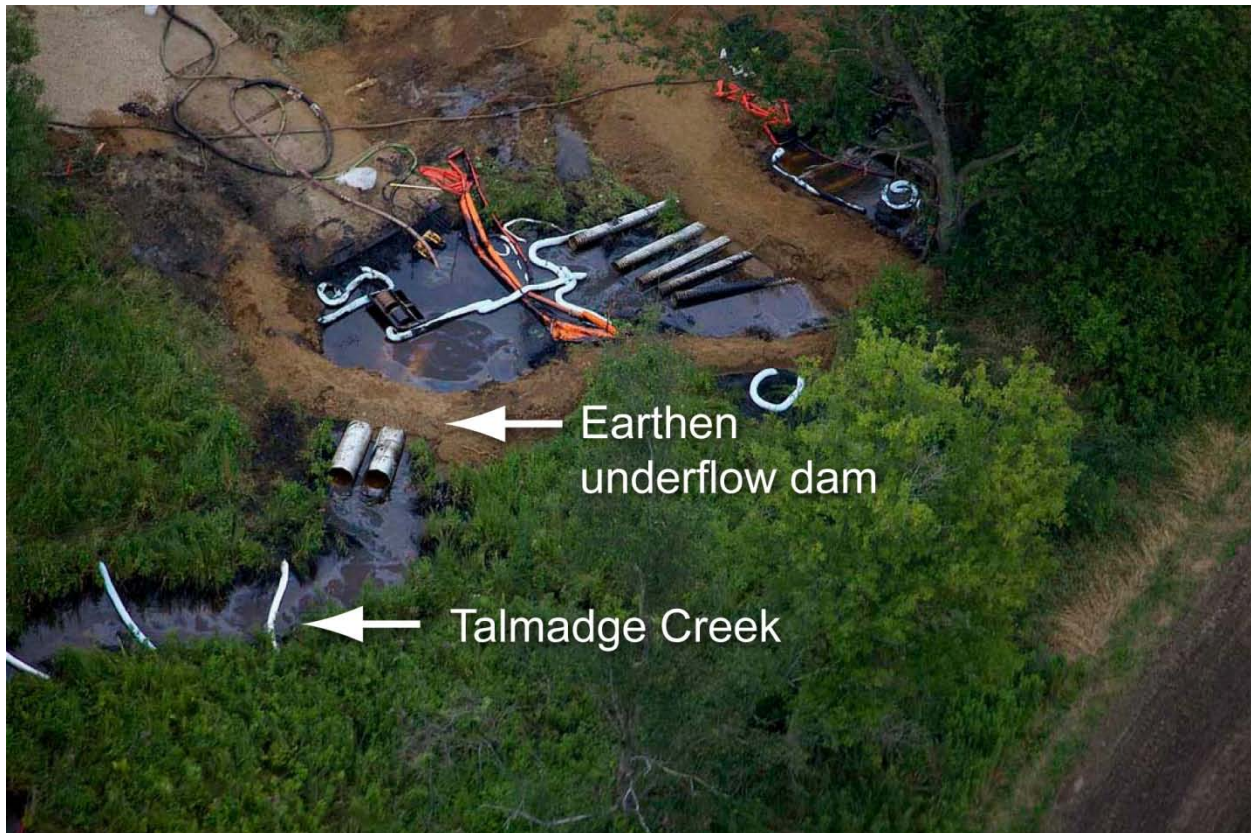
Working with a six-person crew, the Marshall PLM supervisor constructed an earthen underflow dam, which consists of a mound of soil holding back oil-contaminated water with pipes submerged on the dam side and rising toward the discharge end. The angle of the pipe allows the deeper water in the dam to flow downstream, preventing the contaminated surface waters from flowing into Talmadge Creek. (See figure 10.)

Figure 10. Underflow dam on Talmadge Creek on July 30, 2010.

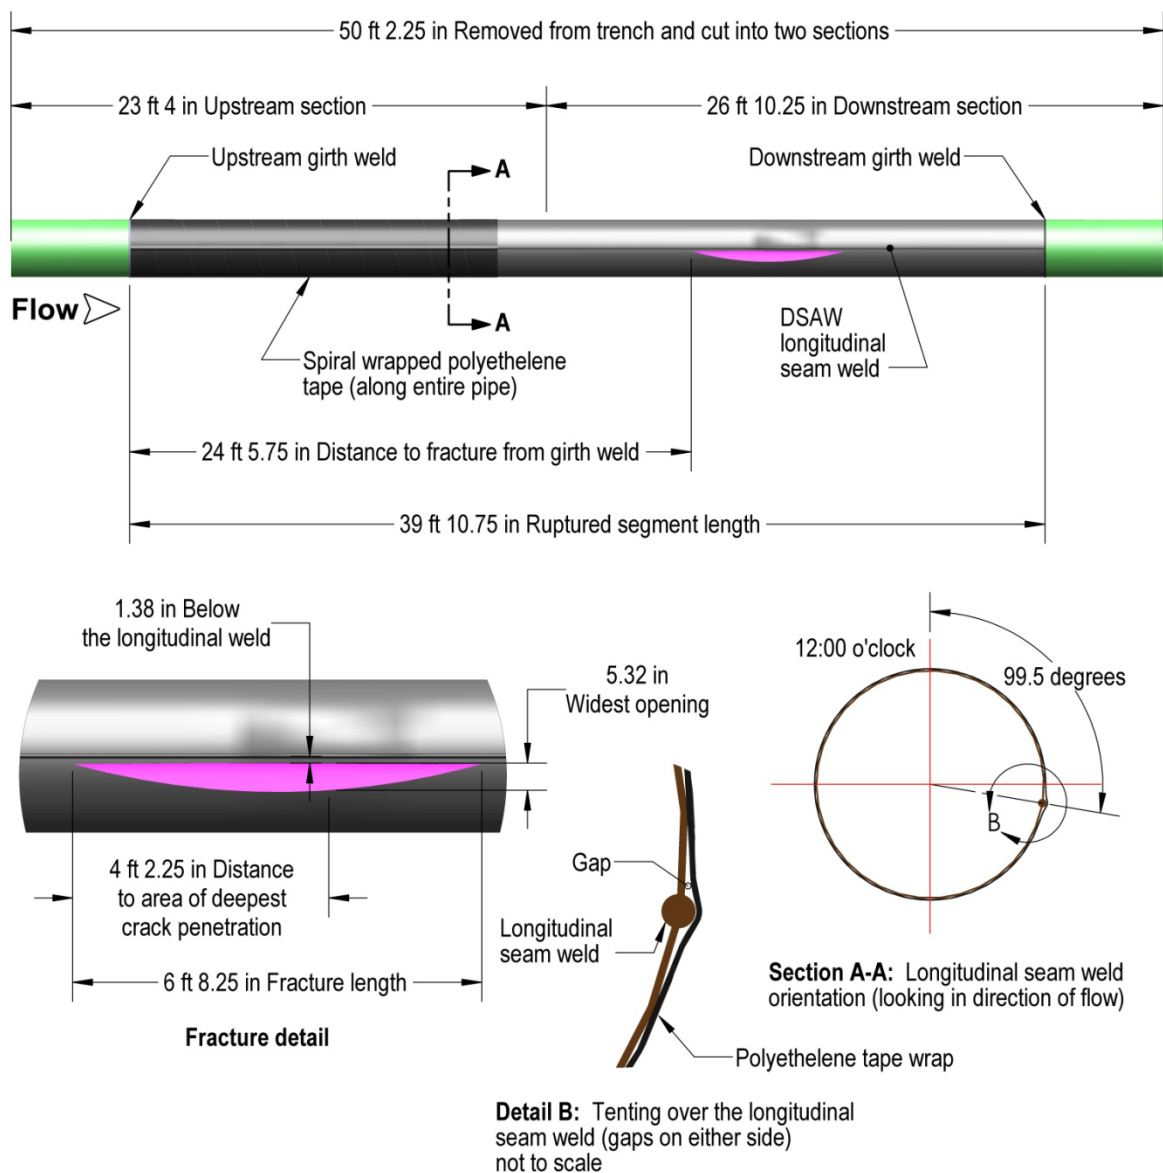
The ruptured pipe segment was 39 feet 10.75 inches long. The longitudinal seam was oriented at 99.5° clockwise.⁴³ A 50-foot length of pipe that included the rupture was removed and cut into two sections for shipping to the NTSB's Materials Laboratory for examination. The upstream section measured 23 feet 4 inches. The downstream section measured 26 feet 10.25 inches. (See figure 11.)

Figure 11. Line 6B ruptured segment showing upstream and downstream sections used for Materials Laboratory examination. Detail B shows tented coating over the longitudinal seam weld.

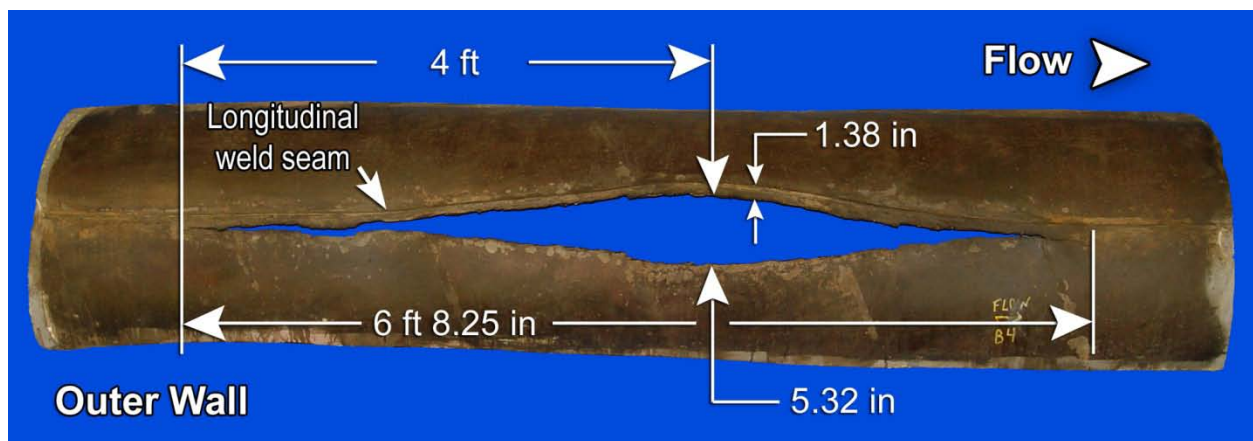
The fracture measured 6 feet 8.25 inches in length with the upstream end of the fracture located 24 feet 5.75 inches away from the upstream girth weld. The widest point along the fracture measured 5.32 inches and was about 4 feet from the upstream end of the rupture. The upper fracture face at the widest opening was measured at 1.38 inches below the longitudinal seam weld away from the heat-affected zone, with this offset ranging from 0.5 to 1.5 inches below the longitudinal weld seam for the length of the fracture face. (See figure 12.)

Figure 12. The outside surface of the pipe looking at the fracture area cut for lab examination.

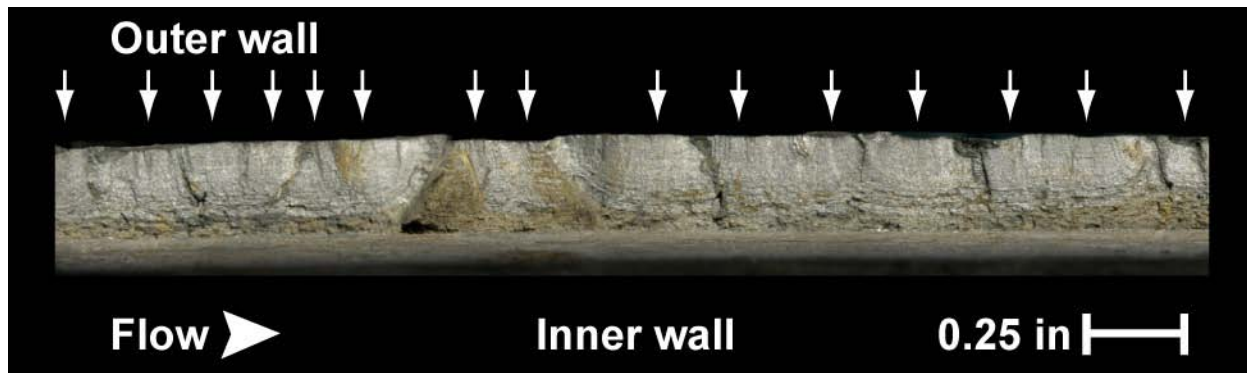
Examination of the fracture face revealed features on slightly offset planes consistent with preexisting cracks initiating from multiple origins in corroded areas on the exterior surface. Evidence of preexisting cracks at various penetration depths was observed across nearly the entire length of the fracture surface. The area of deepest preexisting crack penetration, relative to the original local wall thickness, was located 50.25 inches from the upstream end of the rupture.

Figure 13. Curving arrest lines of preexisting cracks along the upper fracture face shown after cleaning to remove oxides. White arrows indicate multiple origin areas of preexisting cracks.

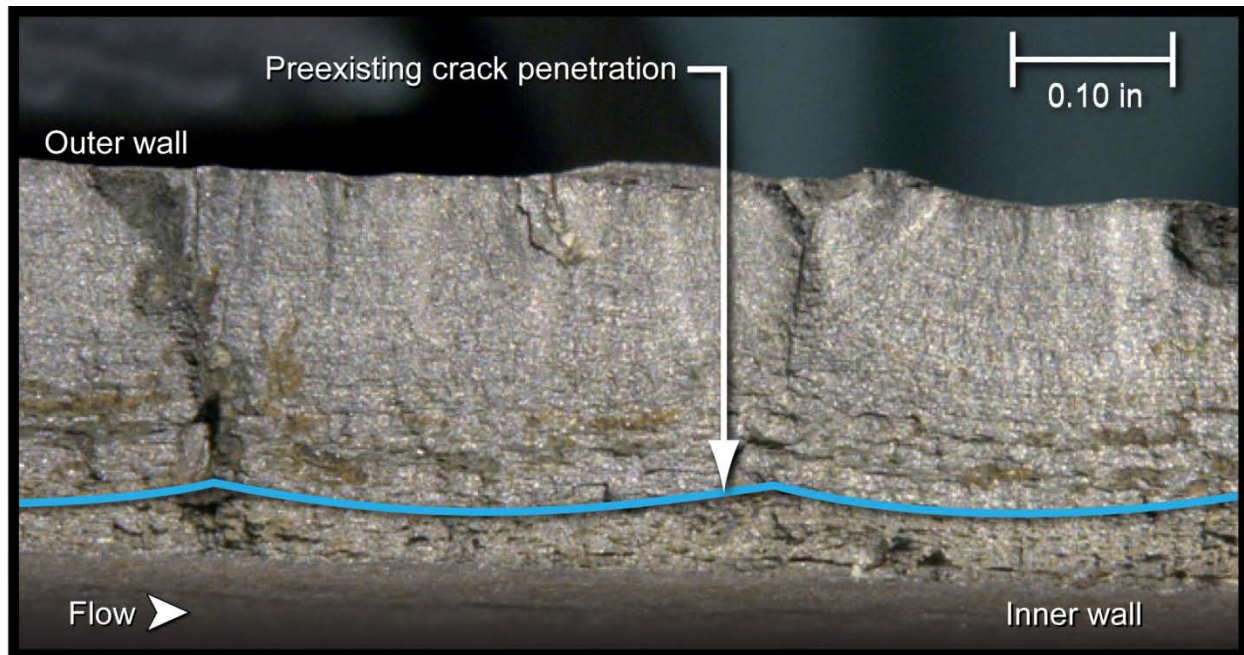
At the deepest crack penetration (see figure 14), the preexisting cracks extended 0.213 inch deep into the wall of the pipe relative to the original exterior surface, or 83.9 percent of the original wall thickness of 0.254 inch. The curving line in figure 14 indicates the extent of preexisting crack growth near the deepest penetration. The remainder of the fracture face had rough, matte gray features consistent with an overstress fracture. The preexisting cracks had fracture features perpendicular to the outside surface, consistent with corrosion fatigue^{46,47} or near-neutral pH stress corrosion cracking (SCC).⁴⁸ Fine crack arrest features were present within about 0.015 inch of the crack origins with broader crack arrest features appearing farther away from the origins. These crack arrest features were indications of progressive crack growth and can be associated with corrosion fatigue or near-neutral pH SCC.

Figure 14. Close view of fracture surface area in the area of deepest crack penetration. The solid blue line indicates the extent of the preexisting crack penetration.

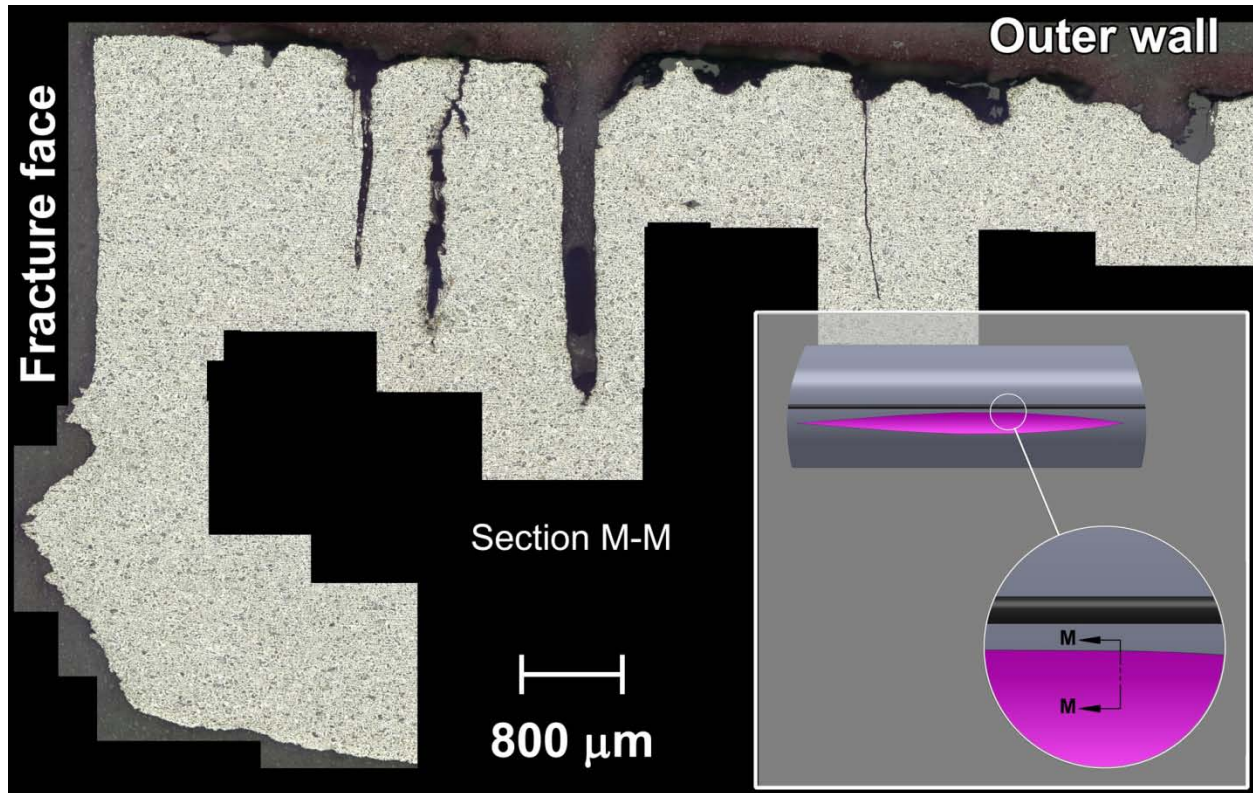
A cross-section through the fracture was prepared as shown in figure 15. The preexisting crack portion of the fracture showed a transgranular⁴⁹ fracture path with limited crack branching, consistent with near-neutral pH SCC or corrosion fatigue. Multiple closely spaced and parallel secondary cracks (with transgranular propagation paths and limited crack branching) emanated from corrosion pits on the outside wall near the fracture face, also consistent with corrosion fatigue or near-neutral pH SCC. The deepest secondary crack extended through about 43 percent of the wall thickness.

Figure 15. Transverse section through the top of the fracture showing multiple parallel cracks emanating from corrosion pits on the outside surface.

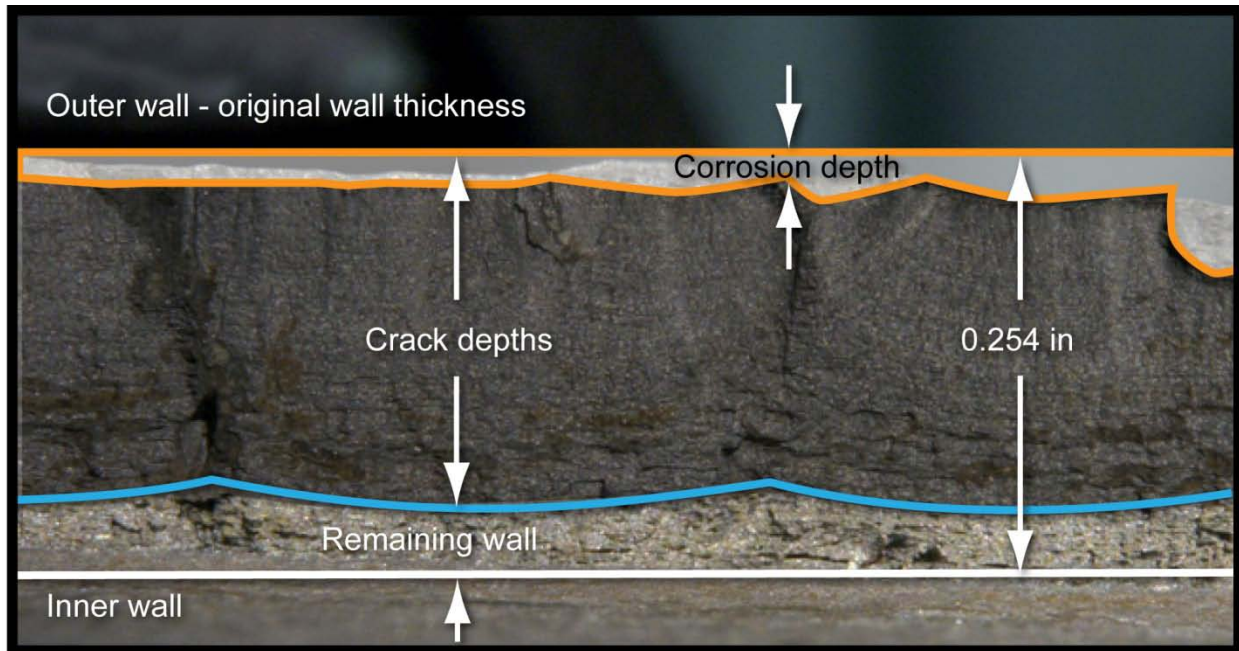
Figure 16. Lab measurements of crack and corrosion depths along the fracture face measured from images similar to figure 14 near area of deepest penetration (about 344 inches from upstream girth weld).

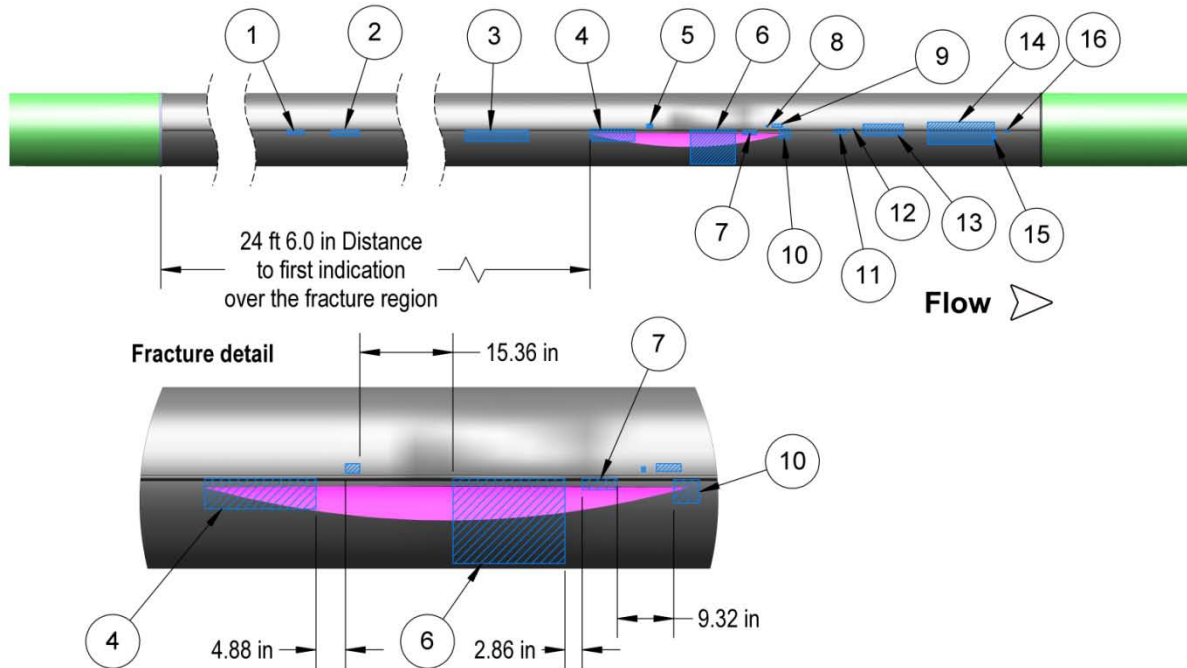
2004 USWM corrosion features on the ruptured segment

Feature ID	Distance from upstream girth weld (ft)	Width of area (degrees)	Local wall thickness (in)	Length of area (in)	Deepest indication (in)
1	10.22	101 - 107	0.268	7	0.047
2	11.73	101 - 109	0.26	11.6	0.047
3	20.24	101 - 118	0.26	25.9	0.055
4	24.5	101 - 120	0.252	18.4	0.055
5	26.44	91 - 97	0.26	2.4	0.047
6	27.92	100 - 153	0.252	18.5	0.087
7	29.7	101 - 108	0.252	5.8	0.047
8	30.52	93 - 96	0.252	0.6	0.047
9	30.72	91 - 96	0.252	4.1	0.047
10	30.96	101 - 116	0.252	4.3	0.047
11	32.87	101 - 109	0.252	4.7	0.055
12	33.41	101 - 104	0.252	1.6	0.047
13	33.82	91 - 109	0.252	16.5	0.055
14	36.02	88 - 123	0.252	27.4	0.063
15	38.24	109 - 115	0.26	1.2	0.047
16	38.7	100 - 104	0.26	1	0.055

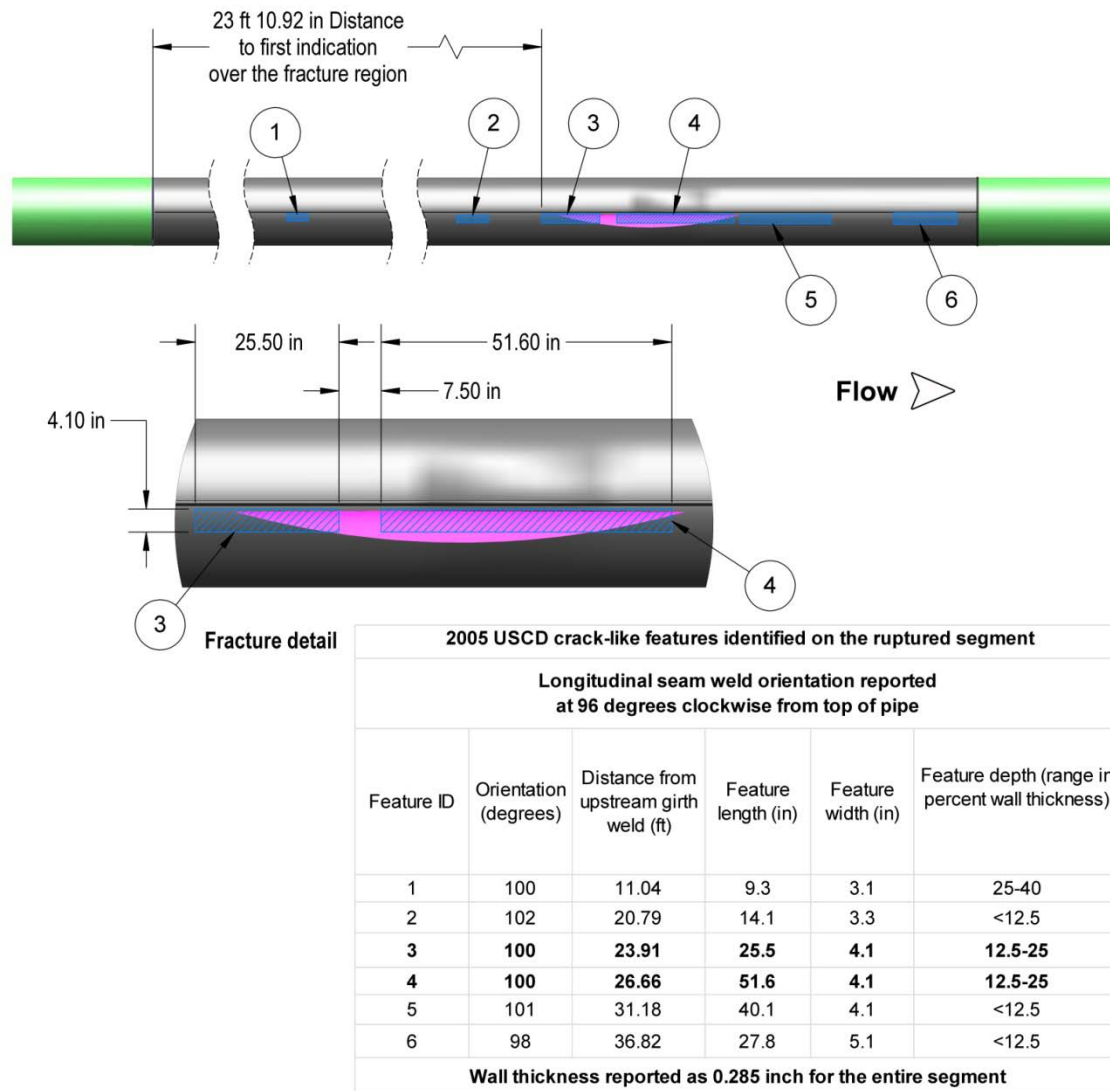
Figure 18. 2005 in-line inspection regions where crack-like characterizations were reported by PII on the ruptured segment of Line 6B.

According to PII, all six features identified on the ruptured segment, including the 51.6-inch-long crack, were originally characterized as crack-field indications by a junior analyst; however, a supervisor changed the analyst’s characterizations to crack-like defects during a final quality check.

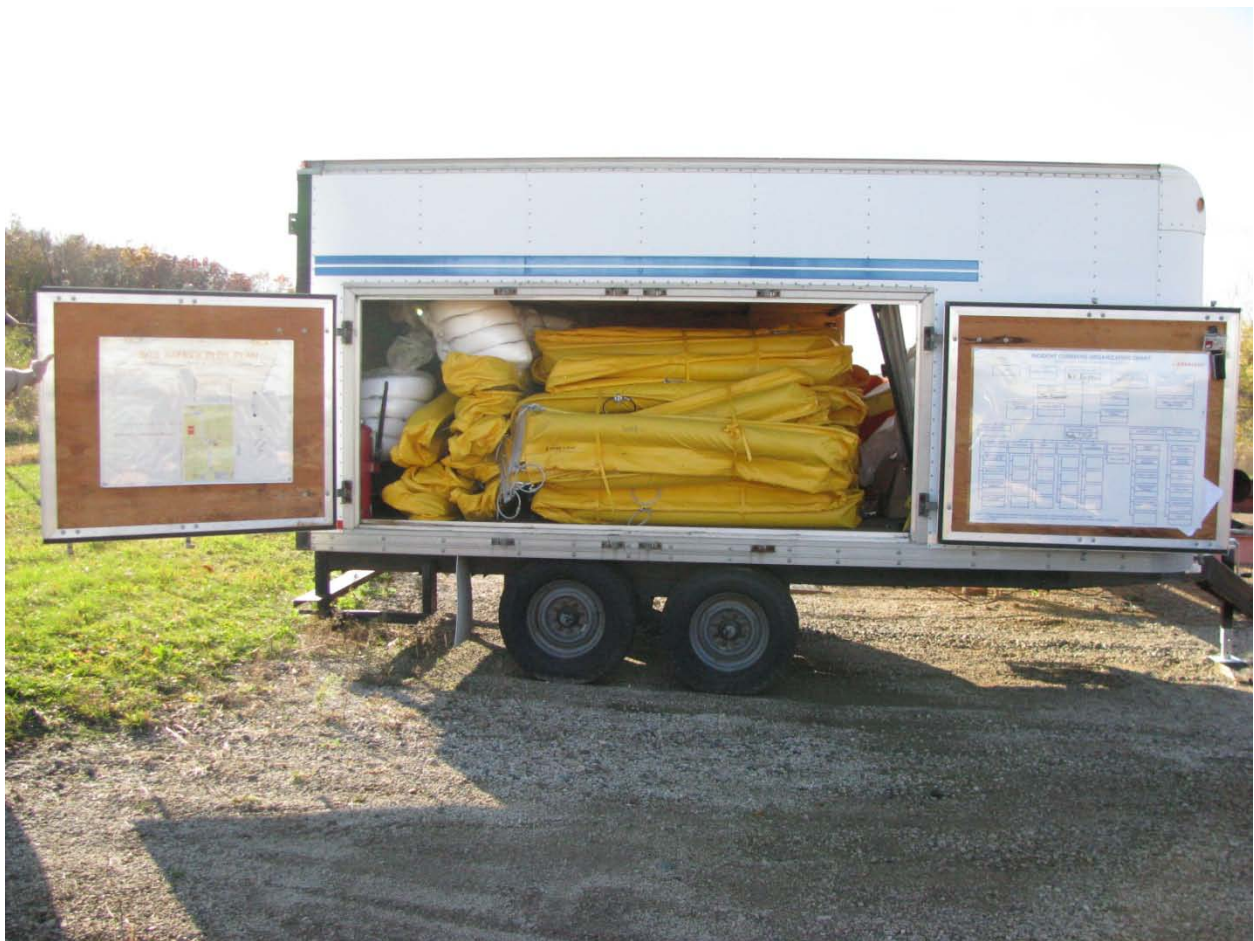
Figure 20. Enbridge PLM emergency response trailer containing the company's Tier 1 oil containment equipment, October 17, 2010.

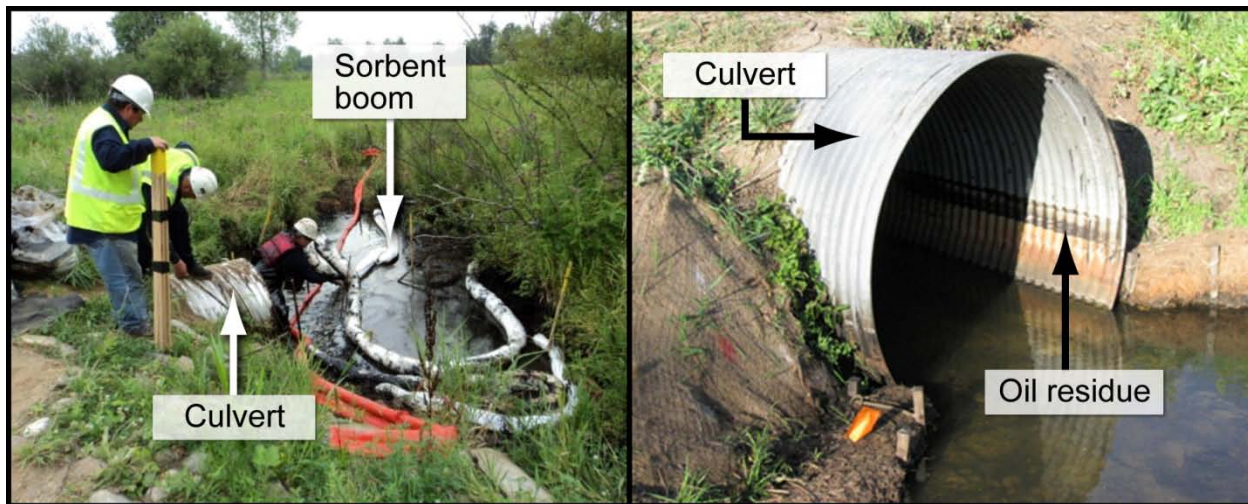
learned from the response, the Bay City PLM supervisor told NTSB investigators that, in the future, he would ensure that sheets of plywood are included in Enbridge's boom trailers so that adjustable underflow dams can be constructed over culvert pipes.

Figure 21. (Left) Enbridge employees install sorbent boom in front of a culvert at Division Drive. (Right) Oil residue marks the level of the oil carried through this culvert following the Enbridge release from Line 6B.
