Enbridge Incorporated
Hazardous Liquid Pipeline Rupture and Release
Marshall, Michigan
July 25, 2010

NTSB/PAR-12/01
PB2012-916501

Pipeline Accident Report

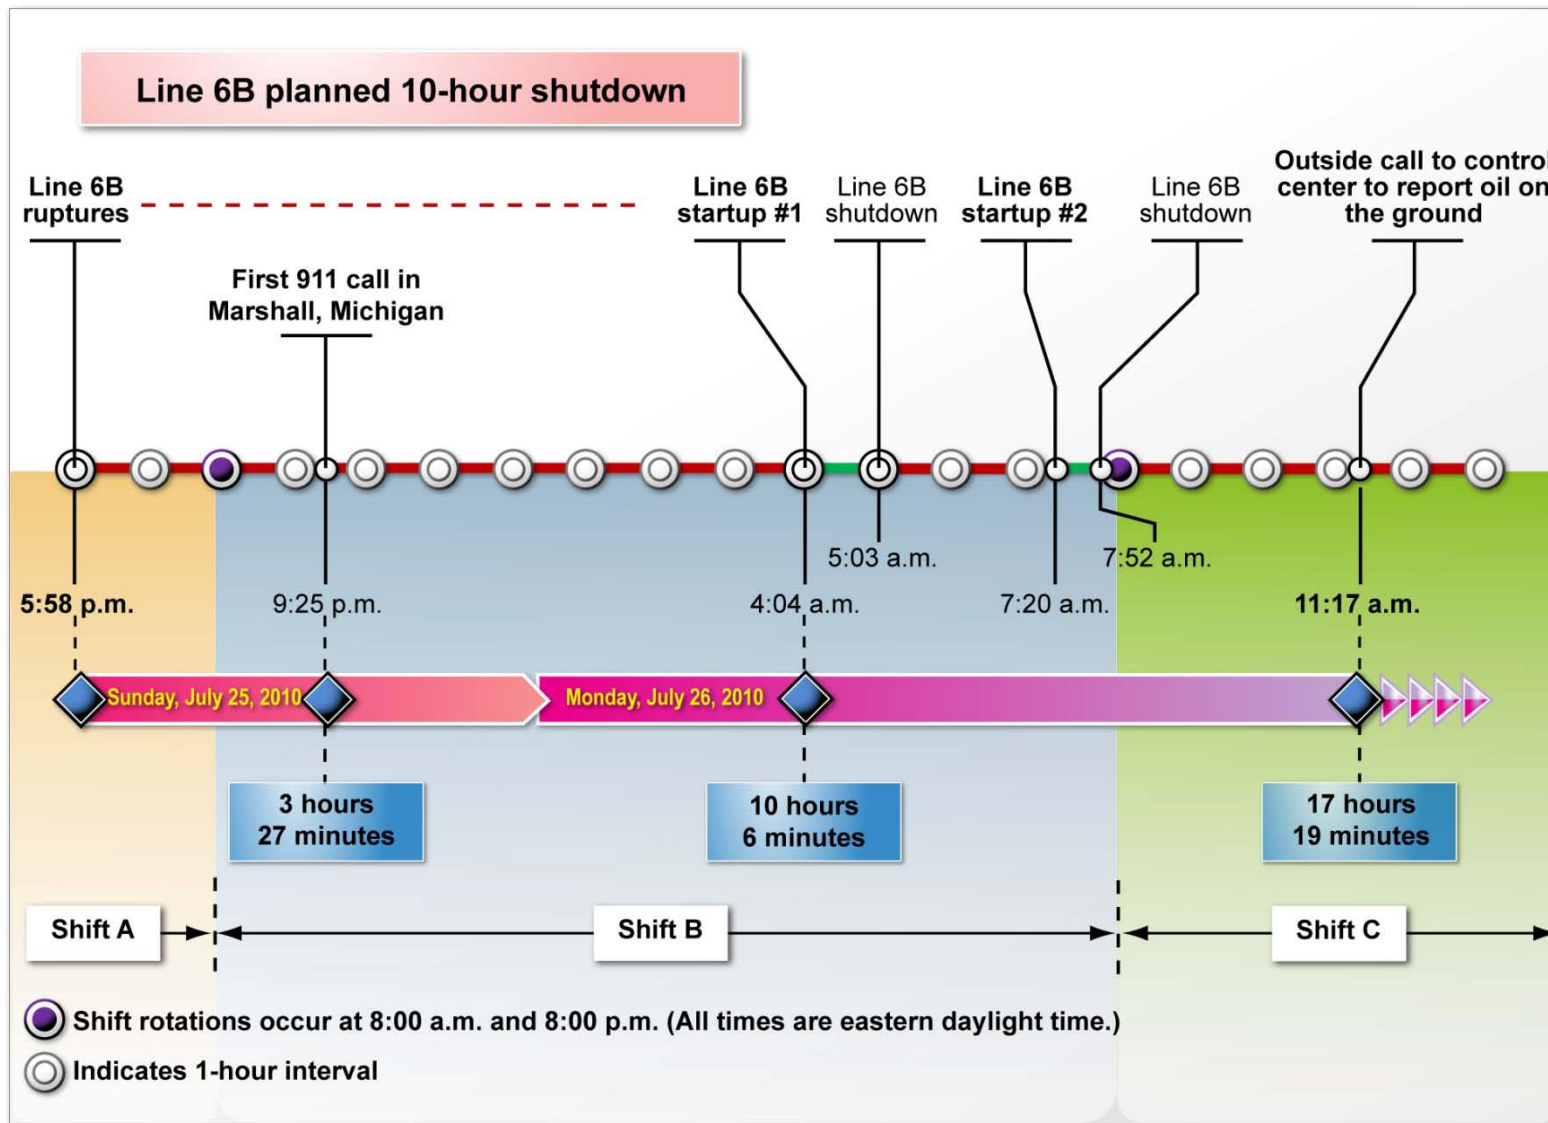
Figure 5 shows a timeline highlighting the accident events that spanned over 17 hours from the time of the rupture until the Enbridge control center was made aware of it. Figure 6 shows the key Enbridge staff involved.

Figure 5. Key events timeline of the Line 6B rupture in Marshall, Michigan, showing the events from the time of rupture on July 25, 2010, to the time of discovery on July 26, 2010.

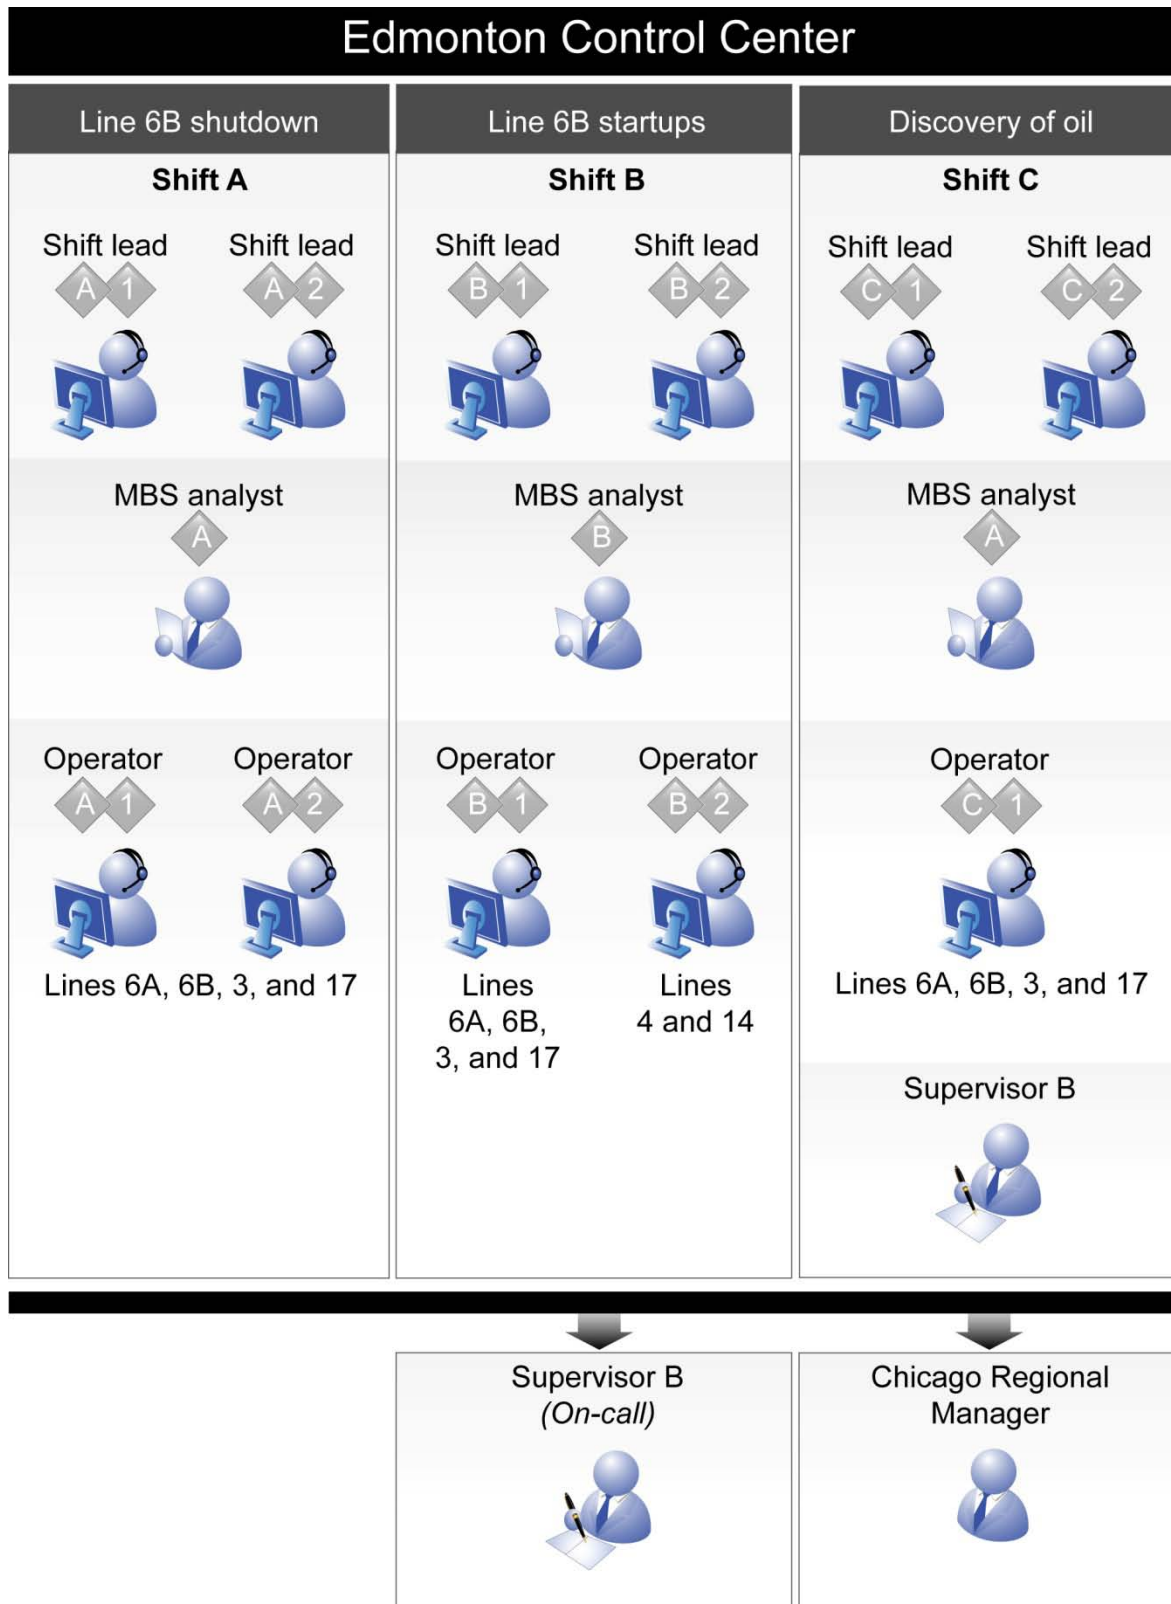
Figure 6. Key Enbridge staff involved in the 17-hour accident sequence. MBS refers to Material Balance System.

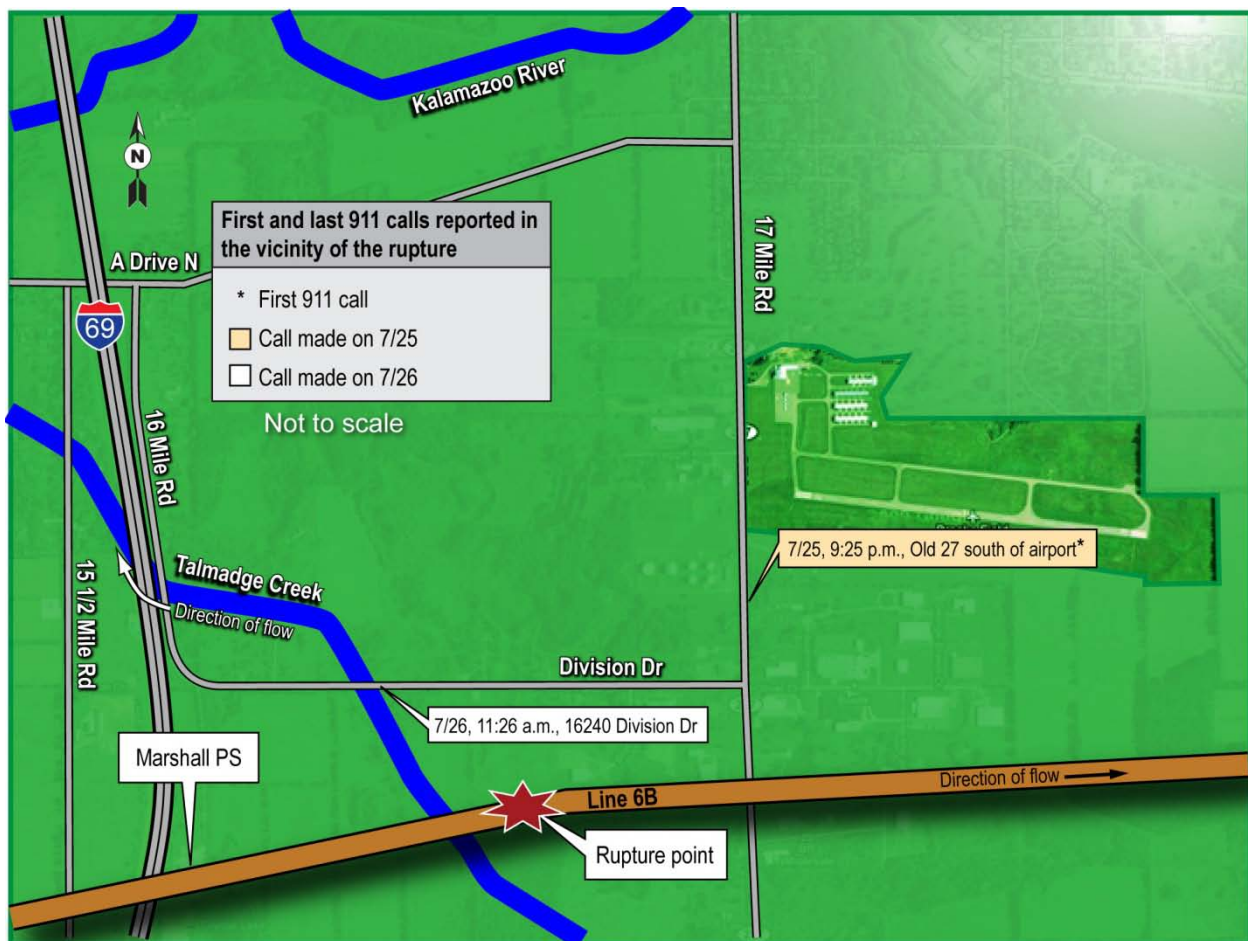
Figure 8. Emergency response and 911 calls from nearby residents. First and last calls are noted.

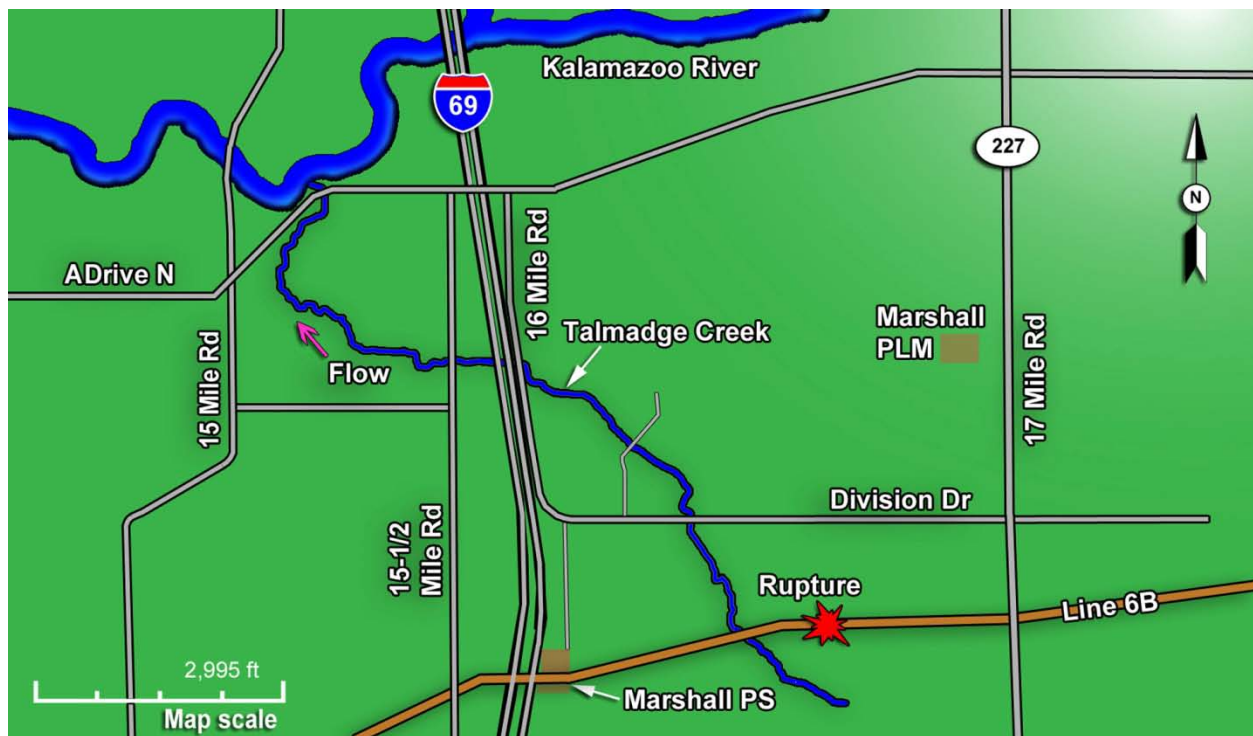
Figure 9. Area between rupture site and the Kalamazoo River where first responders concentrated efforts to contain the released oil.

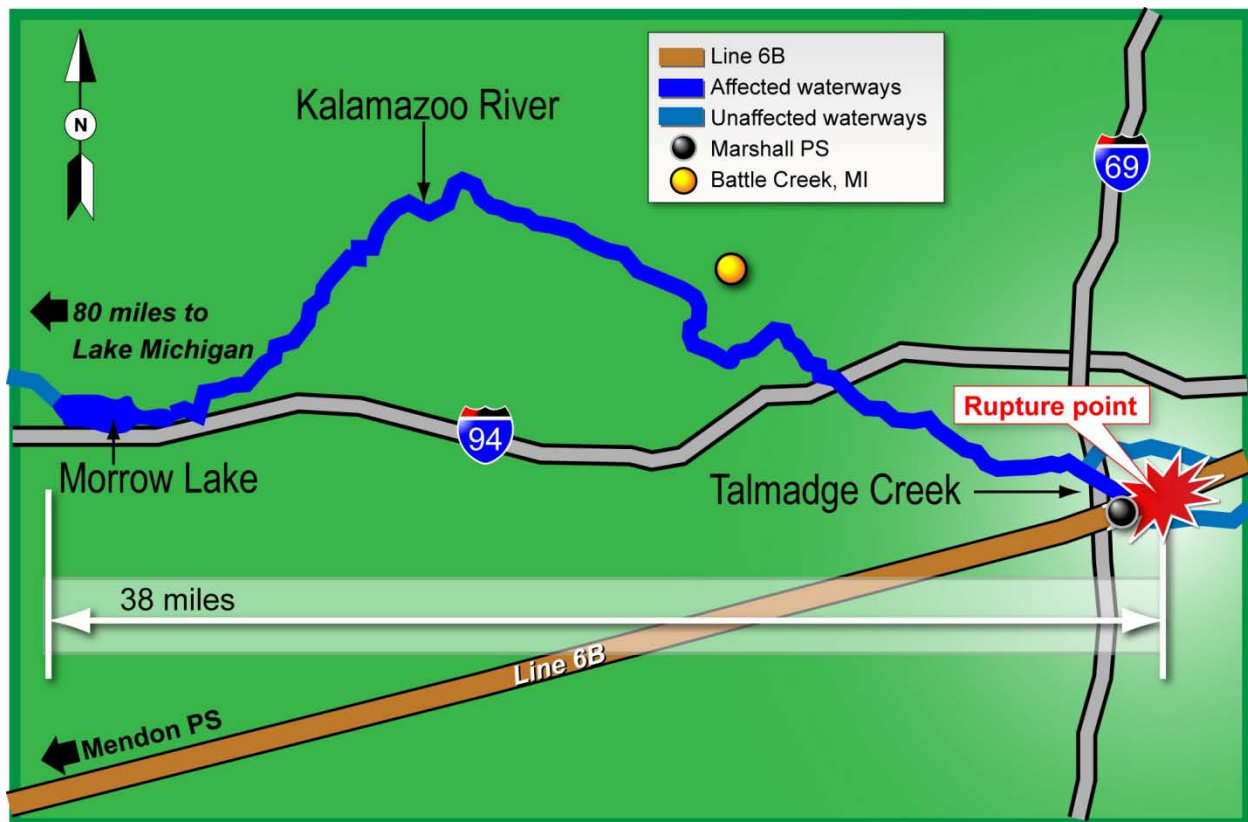
In the days following the accident, Enbridge and its contractors established about 33 oil spill containment-and-control points (from the release site to the west end of Morrow Lake in Kalamazoo County, covering about 38 miles of the river). (See figure 19.) The control points consisted of a variety of oil containment strategies, including underflow dams, oil booming, and sorbent booming. Vacuum trucks and oil skimmers were used to remove oil at these locations.

Figure 19. Map showing rupture location and affected waterways from Talmadge Creek to Morrow Lake.
